# Manhole Inspection Summary

Manhole # S53G\_\_027MH

Insp Date: **9/15/09 2:19 PM**

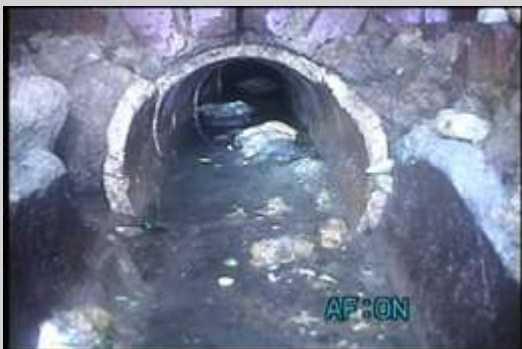
6 O'Clock Inflow

Pipe Height: **8.4** (in.) Rod and Bar (Angled)

Pipe Material: **Clay** ☐ Pipe Lined

Infiltration: **None** Pipe Seal Cond: **Sound**
